# US Pentagon Remote Delivery Facility (RDF)

## Abstract

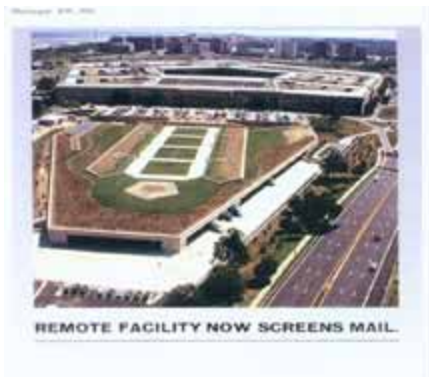
The primary function of the Remote Delivery Facility is security. The building is constructed of highly reinforced concrete.
